TEMPERATURE AND PRESSURE PROFILES OBTAINED DURING BURN OF A SIDEWINDER MARK 17 MOD 5 MOTOR IN A 15,300 CUBIC-FOOT MAGAZINE

DL Technical Report No. TR-3139
September 1974

ABSTRACT

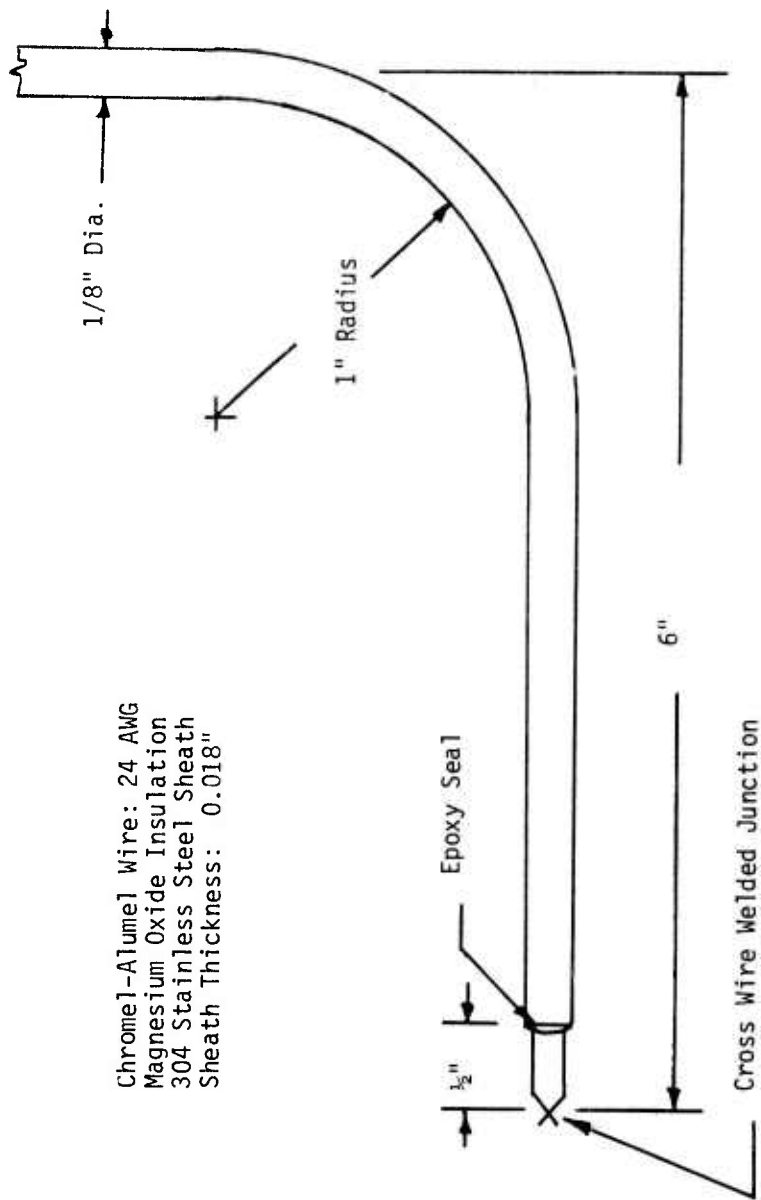
FIGURE A-1
 Thermocouple Detail

(a) Eighty-eight Chromel-Alumel thermocouples (illustrated in Figure 1 of Appendix A) and four strain-gage type pressure transducers were located at selected positions in the magazine (as shown in Figure 2 of Appendix A) to measure free-air temperature and pressure rise in the magazine. Eight of these thermocouples (identified as /s in Figure 2 of Appendix A) were installed with a stainless steel sleeve, (as shown in Figure 3 of Appendix A) to shield the thermocouple from radiant energy during the motor burn. A detailed sketch, (Figure 4 of Appendix A) shows the thermocouple array installation for the test.

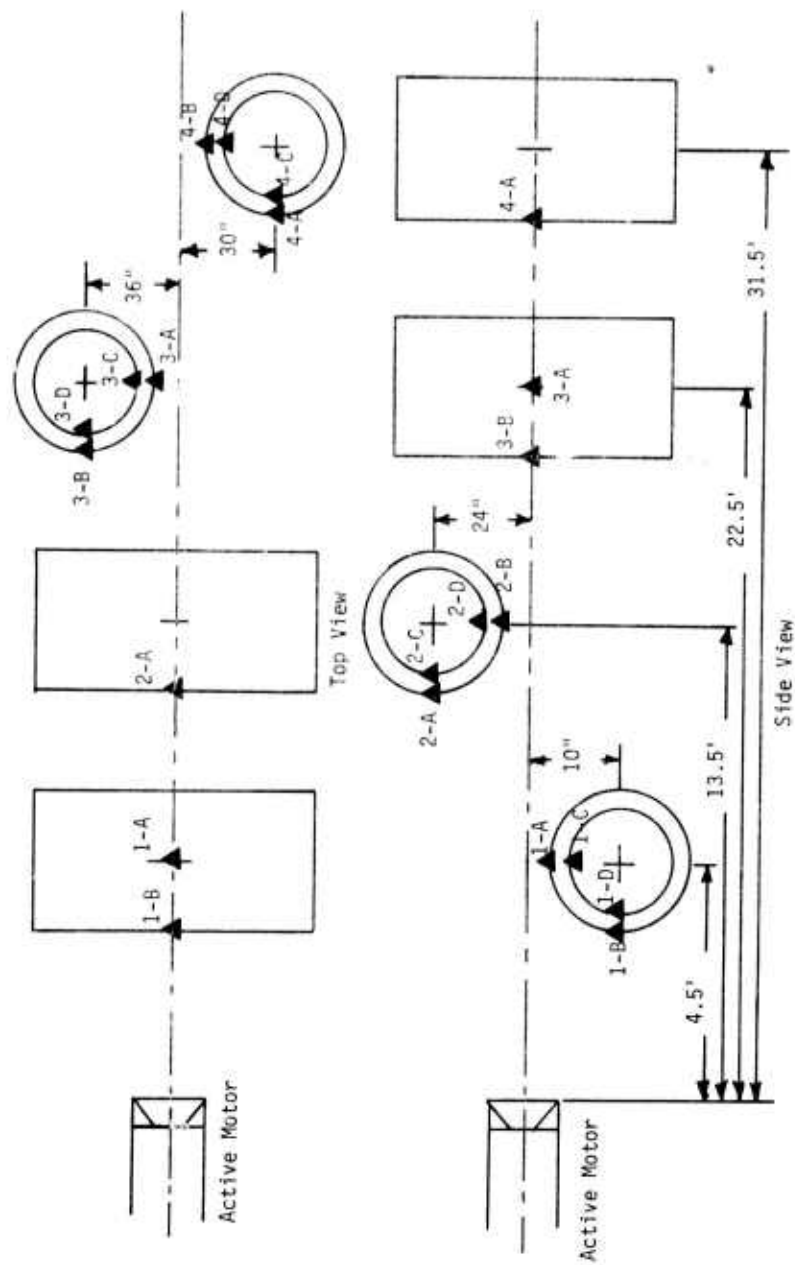
FIGURE A-7
ZUNI Motors in Exhaust Plume

(a) The magazine configuration was the same as for Test No. 1 except that four instrumented, inert-loaded (Filler E) ZUNI motors were located on (approximately) the 400°F isotherm of the active motor exhaust stream as shown in Figure 7 of Appendix A. This configuration gave an indication of the temperatures developed in motors located in the exhaust of a burning motor. Also, this configuration was used to determine the effects of short-term exhaust impingement which would occur if the burning motor could move.

2. Temperature data obtained for the inert, instrumented ZUNI motors (shown in Figures 28 through 31 of Appendix E) located in the 400°F isotherm of the exhaust plume of the active motor also indicate that the temperature was not severe enough to have caused cook-off had the motors been "live". However, ordnance cook-off may occur if there is direct long-term impingement of exhaust gases from an ignited motor.

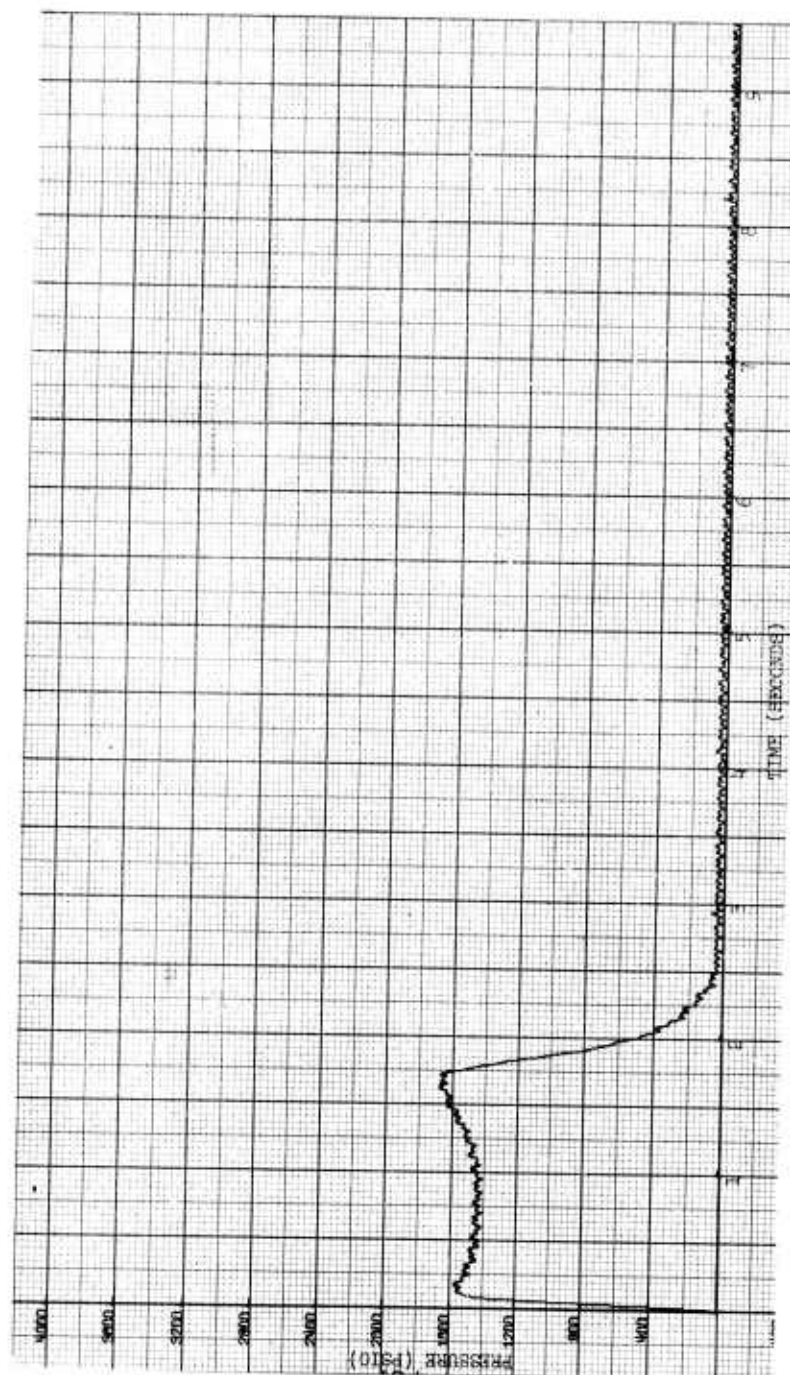
FIGURE B-1
SIDEWINDER MK 17 MOD 5 Motor Pressure
Test No. 1

(1) Figure 1 of Appendix B indicates that normal motor chamber pressure and motor burn occurred.

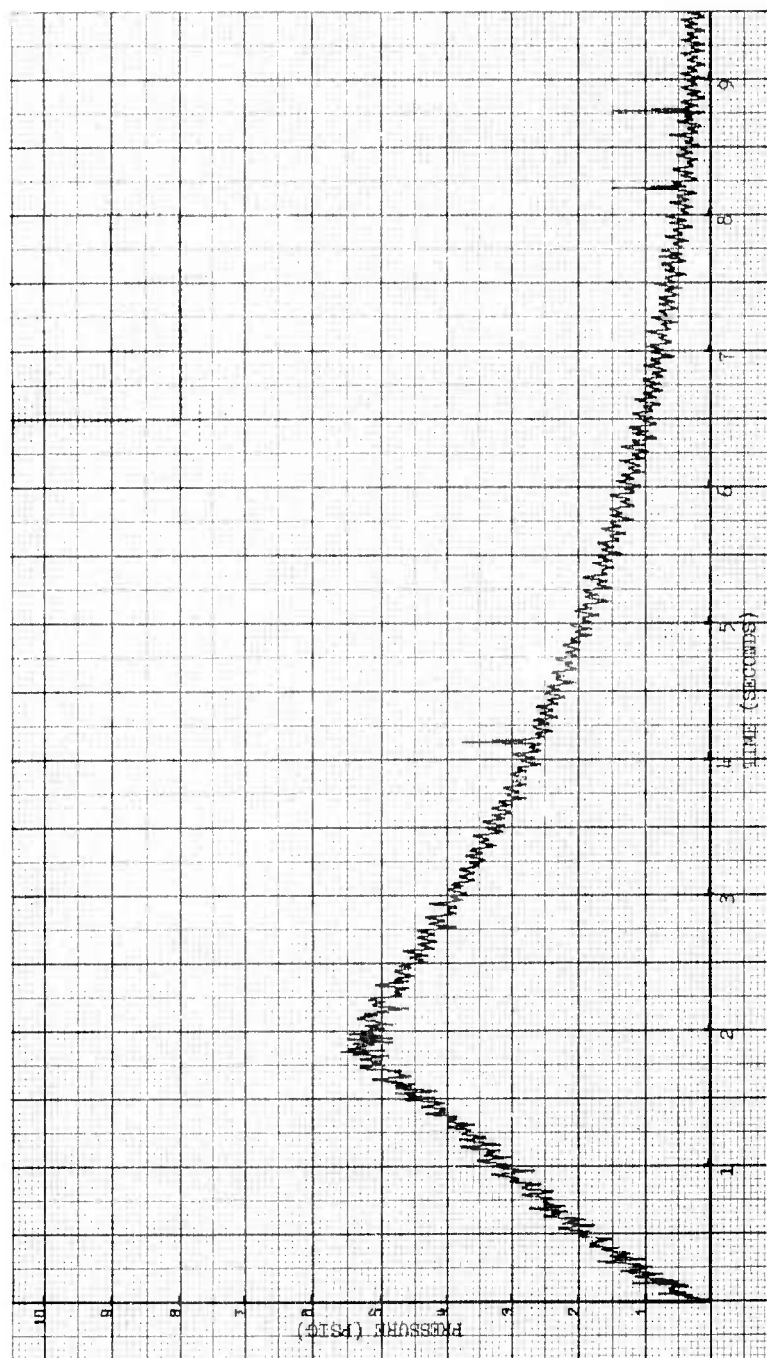
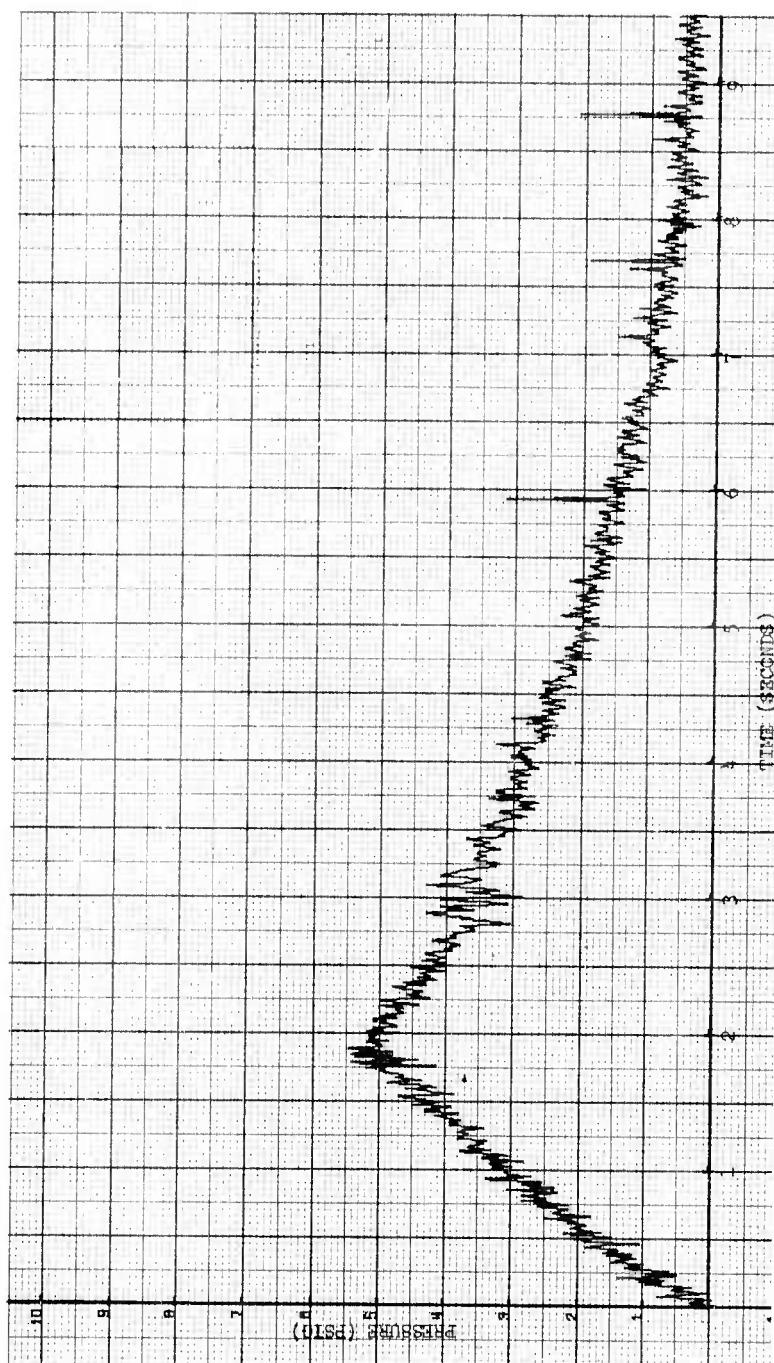
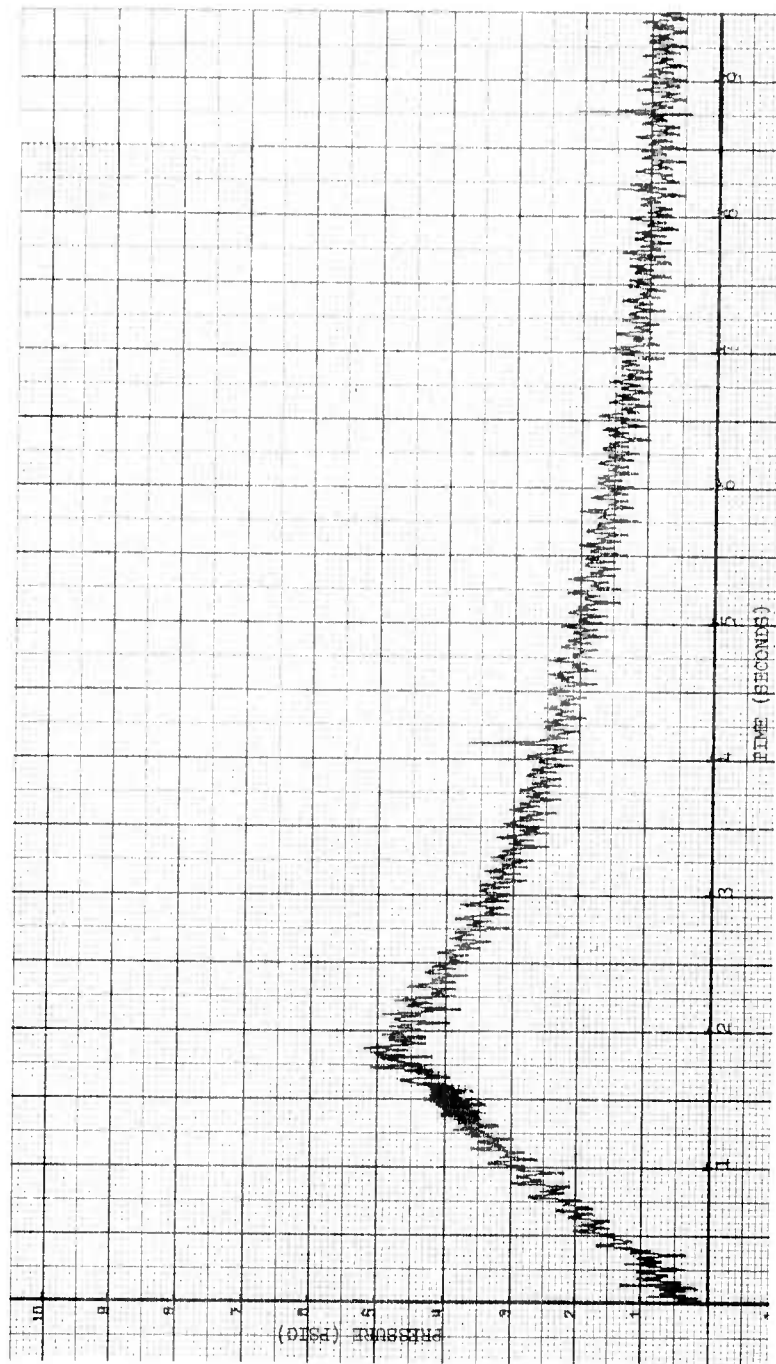
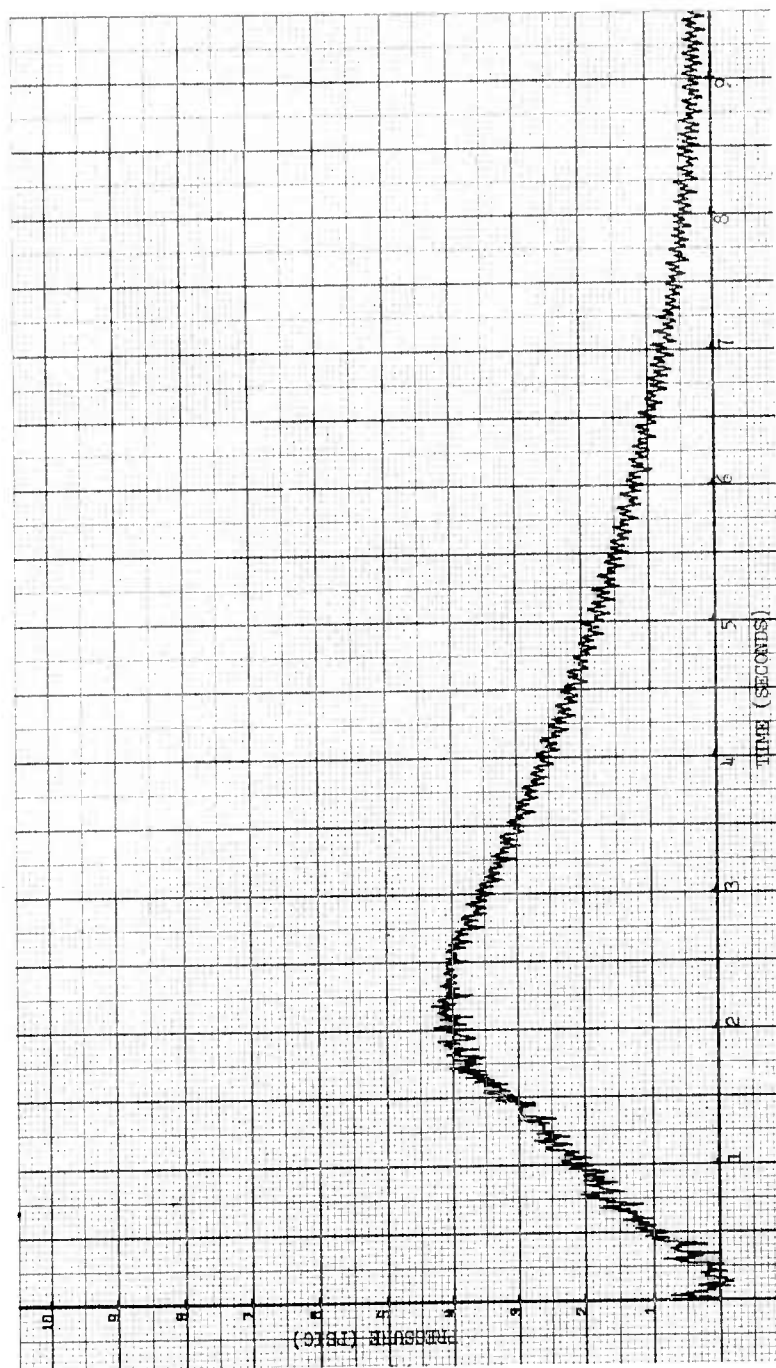
(2) The pressure profile measured inside the test magazine ranged between 3.8 and 5.4 psig, as shown in Figures 2 through 5 of Appendix B.
